<b>DATE:</b>	January 4 <sup>th</sup> , 2016
<b>FROM:</b>	Joe Harrington
<b>SUBJECT:</b>	January Weekly Progress Report @ Gold King
<b>TO:</b>	Steven Way

**Project:** Gold King Interim Water Treatment Plant (IWTP) **Reporting Period:** December 28 – January 4

**Location:** Gladstone, Colorado **Report No.:** 3

**Prepared for:** Emergency Response Unit – US EPA Region 8

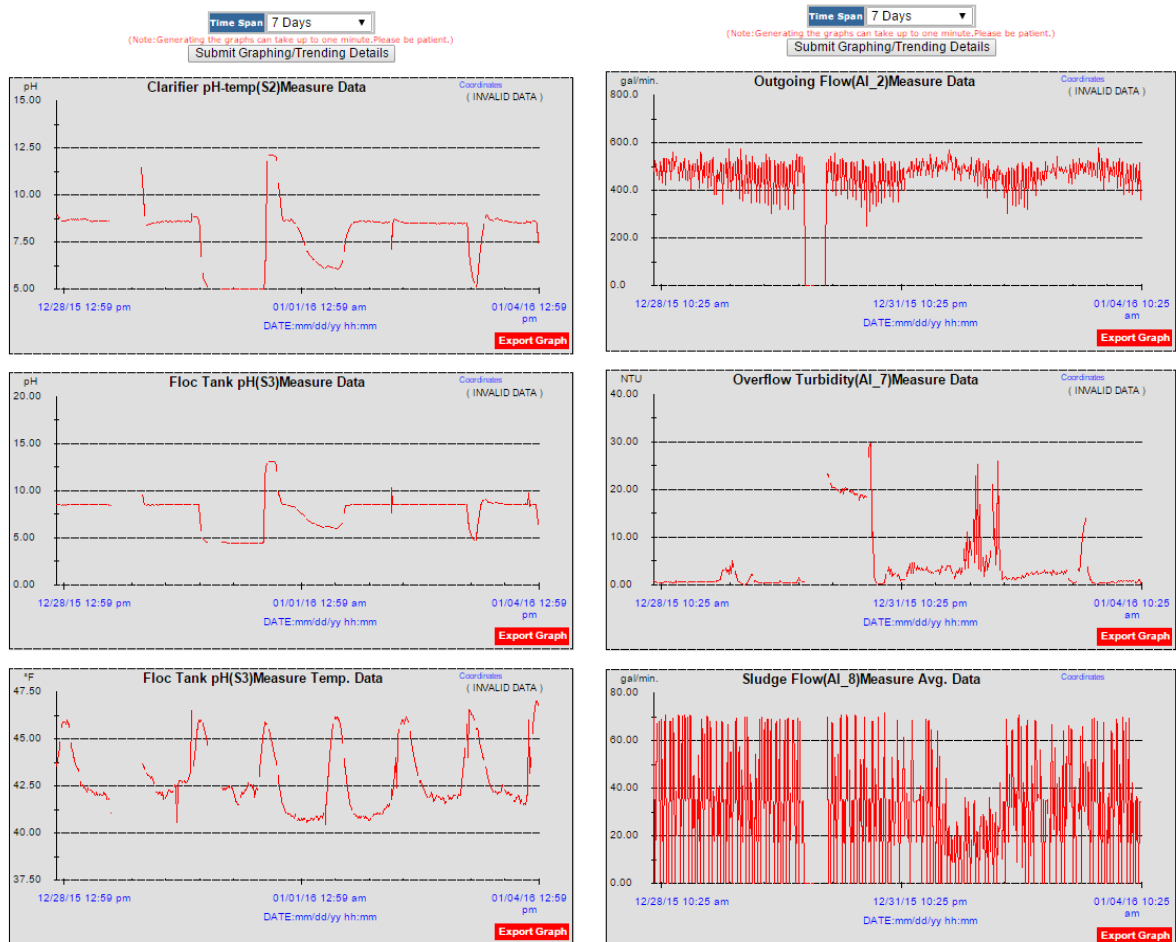
- The following graphs provide trending information collected by datalogging equipment during the previous 7 days. These dataloggers collect control information from the Flow Circuit and Lime Circuit Programmable Logic Controllers (PLCs) at the Gold King IWTP. Over the reporting period (12/28 – 1/4/16 inclusive) Alexco treated 4.18 million gallons at an average of 510 gpm, resulting in 40 gpm to the sludge storage system and 470 gpm to the discharge line.

- As shown in the pH graphs above, a plug developed in the intake to the peristaltic lime feed pump for a duration of several hours on 1/1/16. This plug developed because lime powder was constantly demanded by the control system to the lime slurry tank while with the discharge lines were frozen on 12/31. The operators attempted to clear the thick slurry by discharging at a high target pH in the flocc tank (see spike in pH), but then the system plugged from the thick slurry and the pH again dropped. The obstruction was identified and the on-site operator removed it and restored lime slurry flow. A plug again developed a few days later, which again resulted in low pH water for several hours. In addition to bi-weekly maintenance, the concentration of dry lime added to the slurry tank has been reduced to run for several days with a weaker batch at a higher injection rate. This is done to dilute and break-up much of the thicker lime slurry found in the bottom of the tank and reduce plugging.

- From around noon on 1/1/16 until 10:00am on 1/2/16, the 110v air compressor did not provide sufficient air pressure to fully open the underflow sludge valve on the clarifier. This resulted in a drop in the average flow to the bags and a spike in turbidity the morning of 1/2/16. Once grid power is available, Alexco will switch to the larger compressor system which will provide higher quality and more reliable air to the pneumatic sludge control system. The grid-connected compressors are connected to an air receiver tank system containing 20x more volume of air than the temporary genset-operated air compressor and will be able to operate for more than 1 day without loss of desludging capability.

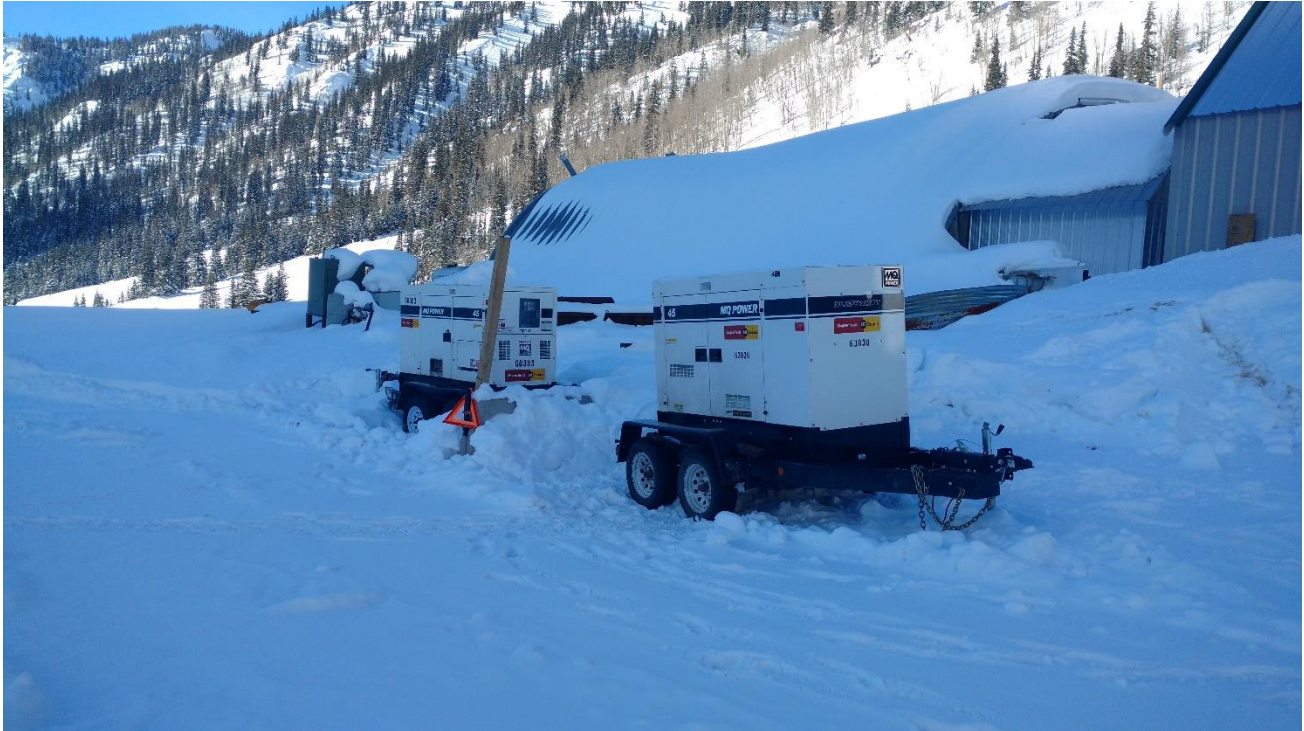
- The IWTP experienced a genset failure from 12:38pm to 8:00pm on 12/30/2015. Alexco immediately called Wagner Rents and a replacement genset was brought up from Durango that evening. The on-site operators and contract electrician stayed late and re-established genset power by 8:00pm. However, during the upset, the heat trace was off on the lime delivery pipelines, and so the pipeline froze before power was reconnected. The lines were thawed and cleaned the next day.

**Photo 1 – Taken 12/30/2015, view of the primary and secondary gensets after both quit working.**

- Repeated Genset Failure: Alexco currently has two electricians at Gold King who are diligently working to transition the system to grid power with an automatic transfer switch for genset back-up.
- Preventive maintenance schedule for cleaning the intake port to the feed line from the lime slurry makeup system.
- Reduced diameter of the feed line from the intake port to the dosing pump (planned, January 12/13 scheduled maintenance).
